DEPARTMENT OF TRANSPORTATION

Contract #: 04-0120F4Cty: SF/ALA Rte: 80 PM: 13.2/13.9File #: 1.28**WELDING INSPECTION REPORT****Resident Engineer:**Siegenthaler, Peter**Address:** 333 Burma Road**City:** Oakland, CA 94607**Report No:** WIR-022115**Date Inspected:** 24-Mar-2011**Project Name:** SAS Superstructure**OSM Arrival Time:** 700**Prime Contractor:** American Bridge/Fluor Enterprises, a JV**OSM Departure Time:** 1530**Contractor:** American Bridge/Fluor Enterprises, a JV**Location:** Job Site**CWI Name:** G. Ehrtson**CWI Present:** Yes No**Inspected CWI report:** Yes No N/A**Rod Oven in Use:** Yes No N/A**Electrode to specification:** Yes No N/A**Weld Procedures Followed:** Yes No N/A**Qualified Welders:** Yes No N/A**Verified Joint Fit-up:** Yes No N/A**Approved Drawings:** Yes No N/A**Approved WPS:** Yes No N/A**Delayed / Cancelled:** Yes No N/A**Bridge No:** 34-0006**Component:** Orthotropic Box Girders**Summary of Items Observed:**

WELDING INSPECTION REPORT

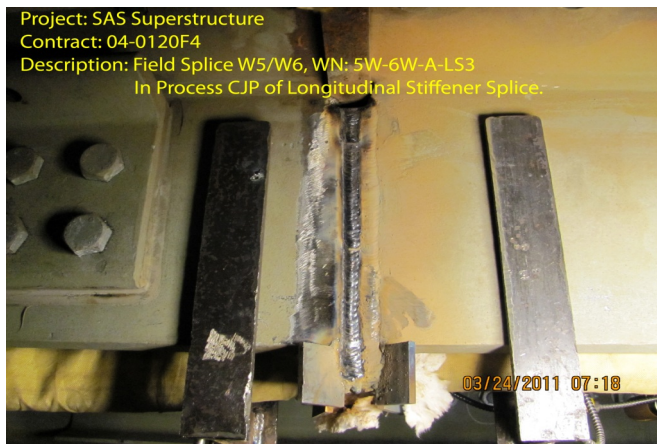
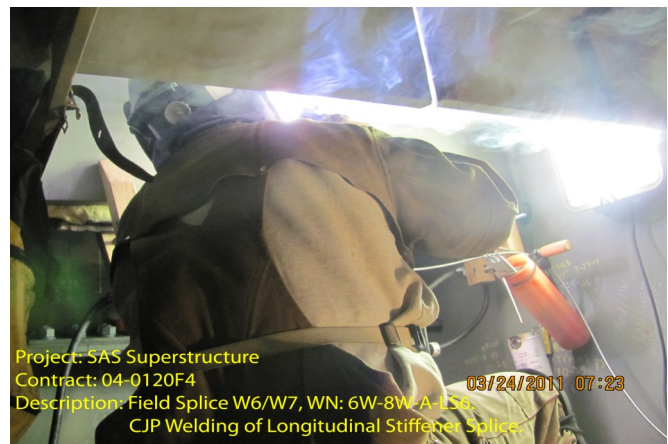
The QA Inspector observed the CJP welding of the longitudinal stiffeners located at the field splices W5/W6 and W6/W7 identified as WN: 5W-6W-A-LS3 and WN: 6W-7W-A-LS3 and LS6. The welding was performed by the welders Xiao Jian Wan ID-9677, Jin Pei Wang ID-7299 and Wai Kitlai ID-2953. The CJP welding of the longitudinal stiffener plates are in progress.

The welding was performed in the vertical (3G) position utilizing low hydrogen electrodes. The welding parameters were verified and recorded by the QC inspector and appeared to comply with the WPS identified as ABF-WPS-D15-1012-3, Rev. 0. The welders utilized a slag hammer and a wire wheel attached to a 4" high cycle grinder to remove slag after the deposit of each weld pass. The 3.2 mm electrodes were stored in electrically heated, thermostatically controlled oven after removal from the sealed containers. The exposure limits of the electrodes identified as E9018-H4R appeared to comply with the minimum storage oven temperature of 120 degrees Celsius as per the contract documents. The WPS's were also utilized by the QC inspector, Gary Ehrsom, as a reference to monitor the welding operation, verify the welding parameters and verify the minimum preheat and the interpass temperatures. The welding parameters and surface temperatures were verified by the QC inspector's utilizing a Fluke 337 clamp meter for the electrical welding parameters and Tempil Heat Indicators for verifying the preheat and interpass temperatures. At the time of the observation no issues were noted by the QAI.

The digital photographs below illustrate some of the work observed during this scheduled shift.
